Classification:	Reference:	Date:
HA01-003A	NTB02-009A	March 18, 2002

## 1999-2002 QUEST REAR A/C OUTLETS BLOW WARM AIR

**APPLIED VEHICLES:** 1999-2002 Quest (V41)

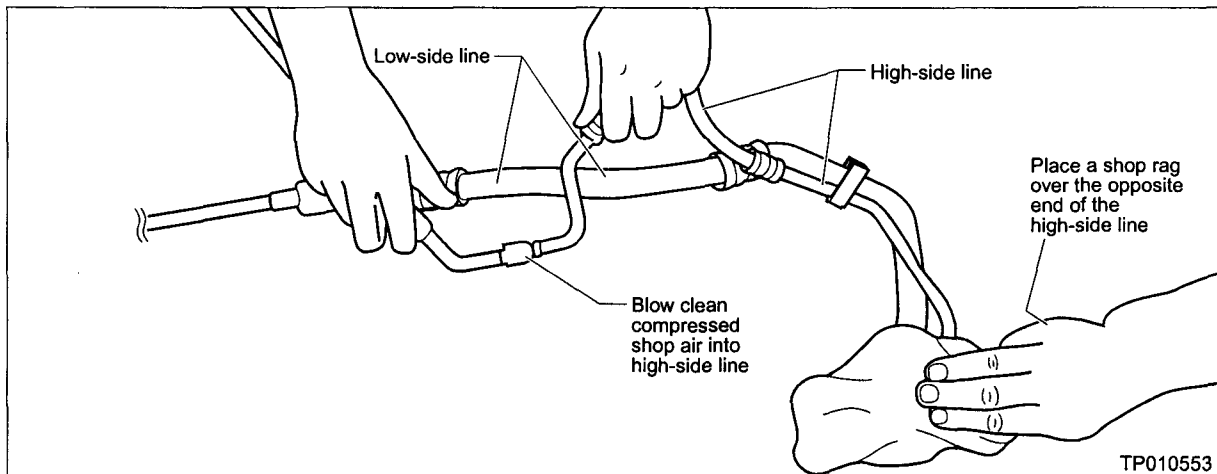
Figure 1

The expansion valve on the rear evaporator assembly (located in the right rear quarter panel area) may be restricted by debris and/or may not be opening properly.

17. Remove the rear evaporator assembly. Place it **carefully** on a workbench.
18. Remove the sealer/black gummy insulator wrapped around the rear expansion valve and thermo. tube/bulb.
19. Remove the rear expansion valve and thermo. tube/bulb from the rear evaporator assembly
20. Inspect the inside of the high-side line for debris. If debris is found, remove it by blowing clean compressed shop air into the high-side line (see Figure 1).

**CAUTION:** Place a shop rag over the opposite end of the high-side line to protect yourself from any debris discharged during this step.

21. Install the new expansion valve and re-attach the high-side line and evaporator tube using new o-rings (see the PARTS INFORMATION section for more information).
